**Re: Request for Information  
Docket No. CWA-IR-16-002  
EPA Sanitary Sewer System Compliance Evaluation Inspection June 10, 2015  
Borough of Carteret  
ICIS/NPDES No. NJP002551  
NJDEP Program Interest ID No.94055 Sanitary System**

**SANITARY SEWER SYSTEM**  
**COMPLIANCE EVALUATION INSPECTION REPORT**

**Compliance Evaluation Inspection:** Borough of Carteret

**Inspection Date:** June 10, 2015

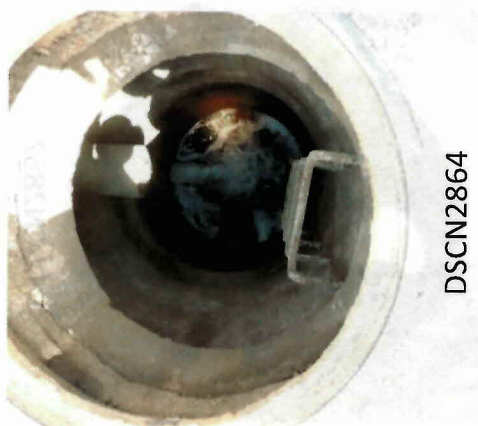
DSCN2864

- j. As shown in photo 2864 there was a pipe high in the manhole, but it is unknown what this pipe is for or if it is in use. Please identify what this pipe is used for or if it has been sealed.

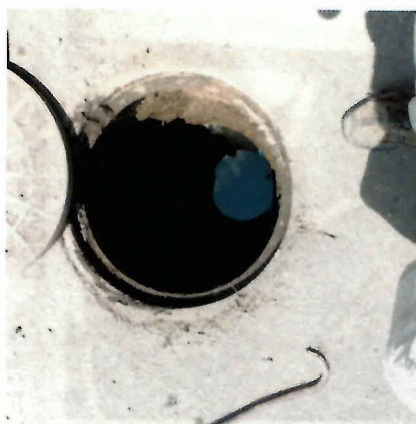
- k. As shown in photo 2865 there was debris high in the manhole – a sign of surcharging at this Roosevelt Ave. Manhole.
- l. As shown in photo 2866 there was a manhole with water in it with a stagnant flow at or near Roosevelt/Roosevelt. Please verify the status of this manhole (storm or sanitary) and whether there is a blockage in the line and any actions that are needed at this location.

DSCN2865	Manhole – thought to be Roosevelt where Kinder Morgan flow comes in. Also debris on top rung of ladder – said to be due to past storms.
DSCN2866	Manhole - halfway filled with water at/near Roosevelt/Roosevelt

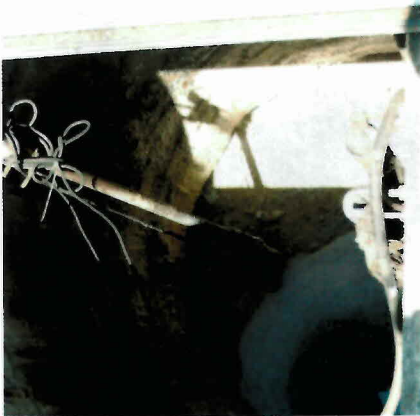
- h. As shown in photos 2859 and 2860 there was a buildup of grease in the wet well at the Harrison Pump Station. As shown in photo 2861 the basket at the influent

to the wet well was also full of rags and grease and was in need of cleaning. Carteret either on its own or with the Health Dept. or other agencies take measures to reduce grease discharges into the Harrison Pump Station.

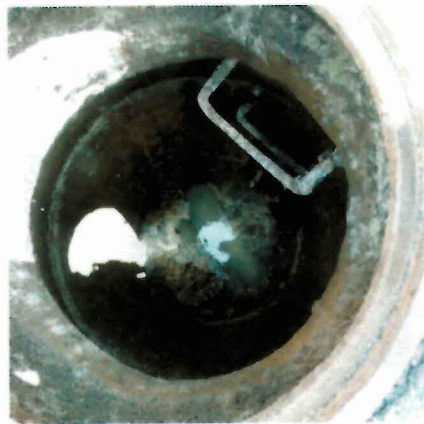
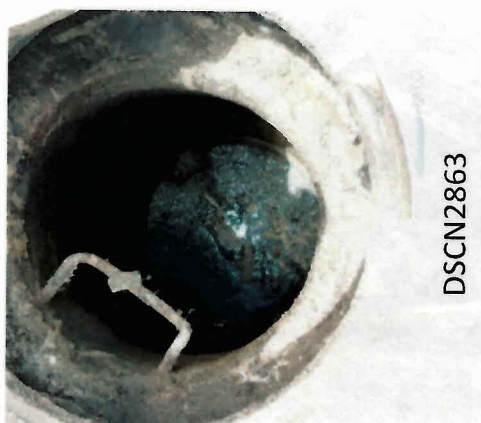
- i. As shown in photos 2862 and 2863 there was a buildup of rags and grease/debris in the Shop Rite Manhole and the manhole upstream of the Shop Rite Manhole. Carteret and other agencies should work with Shop Rite and any other sewer system users in that area to reduce the amount of rags/grease/debris entering the sanitary sewer system.

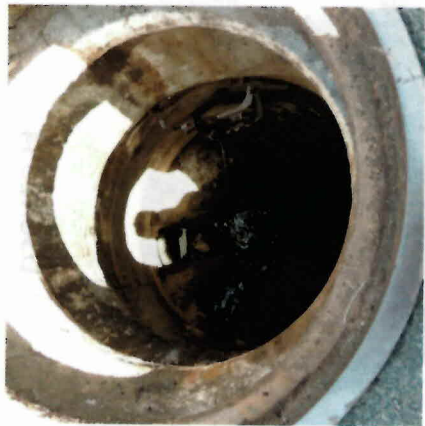
DSCN2856

- e. As shown in photo 2856 there was some debris in the sanitary sewer at Poplar and Coolidge. Also there was signs of past surcharging with debris on the top rung of ladder.

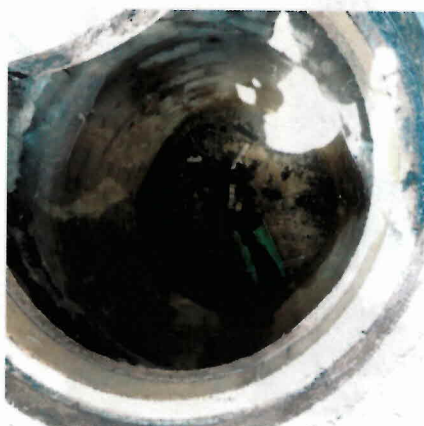
DSCN2858

- f. As shown in photo 2857 there was debris in one of the lines entering the manhole at 15 Van Buren, that was in need of cleaning.
- g. As shown in photo 2858 there were bricks and other debris in the sewer at Chestnut and Jackson, the line was in need of cleaning/vacuuming.

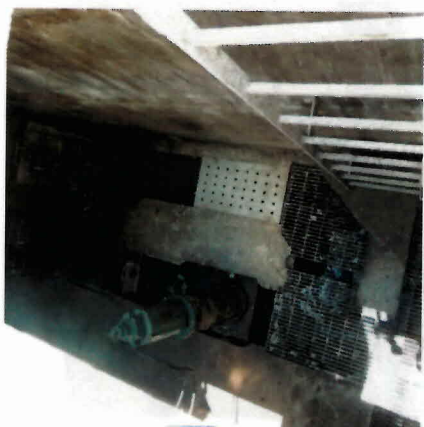
- c. Hudson and Mercer – As shown in photo 2854, Manhole had debris on the 3<sup>rd</sup> rung of ladder, signs of past sewer surcharging.
- d. The comminutor at the Bergen Pump Station was not working – see photo 2855. The flow now goes through the bar screen that is cleaned once per week. The Engineer was to bid out a new comminutor. What is the status of replacement/repair of the Bergen PS comminutor?

DSCN2855	Comminutor at the Bergen Pump Station was not working
DSCN2856	Poplar and Coolidge - signs of surcharging - debris on top run of ladder – some debris in the sewer line as well.
DSCN2857	Debris in one of the lines entering the manhole at 15 Van Buren
DSCN2858	Chestnut and Jackson – Bricks and other debris in the sewer.
DSCN2859	Harrison Pump Station - There was a layer of grease and debris covering about half the surface of the pump station wet well
DSCN2860	Harrison Pump Station - There was a layer of grease and debris covering about half the surface of the pump station wet well
DSCN2861	Harrison Pump Station – the influent basket was filled with grease, rags and debris and was in need of cleaning.
DSCN2862	Shop Rite Manhole – a build up rags was seen in the manhole
DSCN2863	Manhole upstream from the Shop Rite Manhole seen in Photo 2862 also with a build up of material in it.
DSCN2864	Manhole - potentially where the New World flow comes in. – Pipe seen at top of manhole

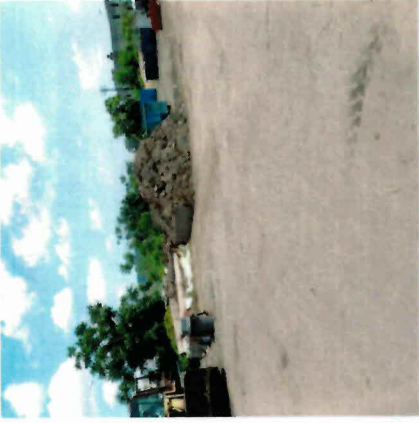
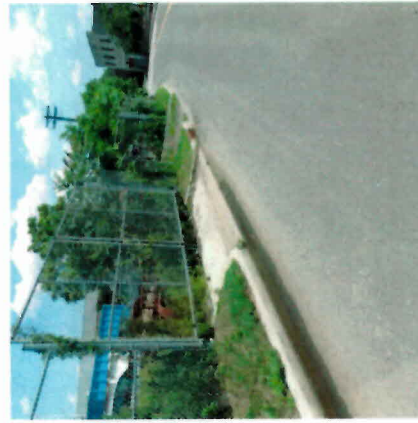
- b. As shown in photos 2852 and 2853 there is a potential of materials stored at the site to be discharged via stormwater. Consideration of stormwater contamination associated with public works facilities under its Municipal Separate Storm Sewer System ("MS4") Permit.

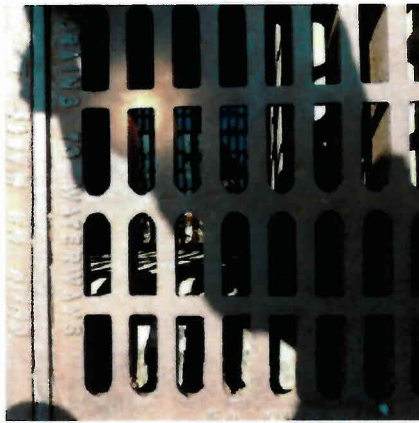
DSCN2851

- a. As shown in photo 2851, Catch basin at the Carteret Public Works facility were in need of cleaning. These catch basins were cleaned during the inspection. Routine maintenance of catch basin is important to prevent discharges of solids/floatables to area waterways.
